Manhole Inspection Summary

Manhole # S41C2_020MH

Location Address: **813 Elarton Ct**

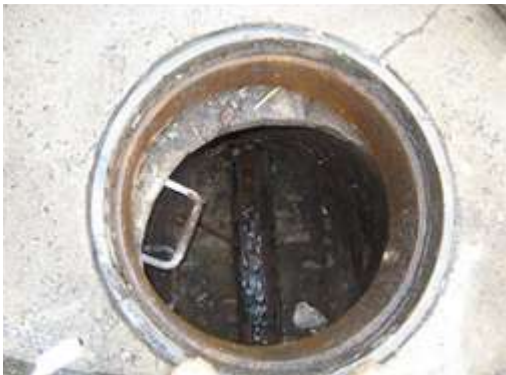
Top View

steps

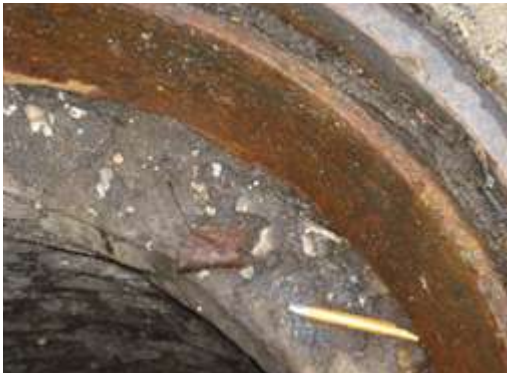
Defect 1

Frame Offset: **6** (in.) Condition: ☒ Sound ☐ Cracked ☐ Leaks

frame offset

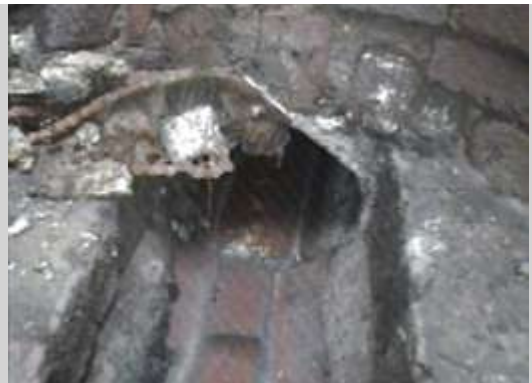
12 O'Clock Outflow

8 in. Circular Gravity Sewer
Pipe Out @ 12 O'Clock

Invert Depth: **6.14** (ft.) Flow Characteristics: **Fast**

Infiltration: **None**

Pipe Seal Cond: **Sound**

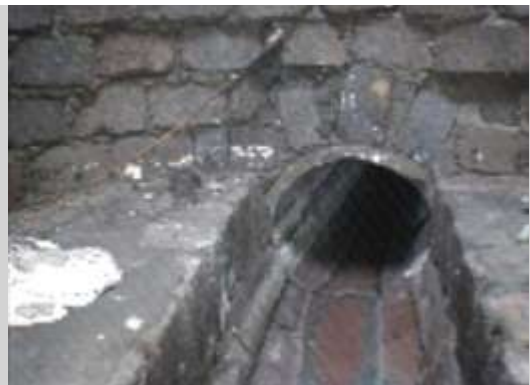
6 O'Clock Inflow

8 in. Circular Gravity Sewer
Pipe In @ 6 O'Clock

Invert Depth: **5.86** (ft.) Flow Characteristics: **Fast**

Infiltration: **None**

Pipe Seal Cond: **Sound**
